Manhole Inspection Summary

Manhole # S35EE1021MH

Insp Date: **1/31/07 8:38 AM**

Location Address: **203 SAINT MARTINS RD**

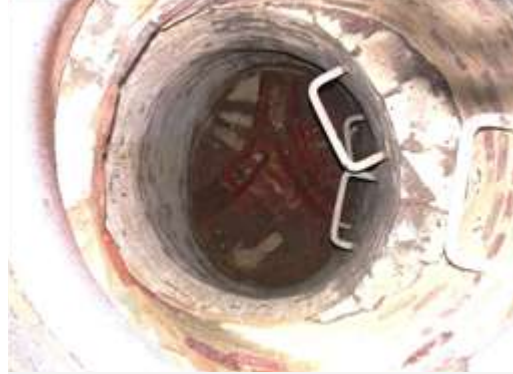
Top View

Bench and Channel debris.

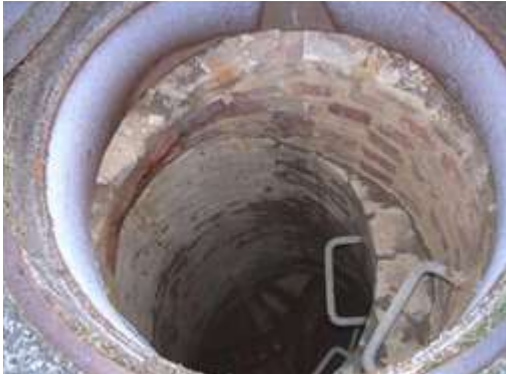
Defect

Condition: ☐ Sound ☐ Cracked ☐ Root Intrusion ☐ Loose Brick ☒ **Deteriorated**

Infiltration: ☐ None ☒ **Joint** ☐ Cracks ☐ Mortar ☐ Roots ☒ **Wall**

Frame leaks. Frame offset. Adjustment deterioration and infiltration. Corbel and Barrel infiltration.

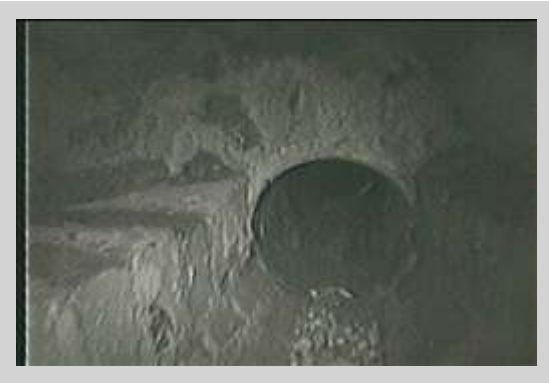
8 in. Circular Gravity Sewer
Pipe Out @ 12 O'Clock

Deposits: ☐ None ☐ Mud ☐ Sludge ☒ **Debris** ☐ Grease

Silt Depth: **0.5** (in.) Deposits Extent: **Light**

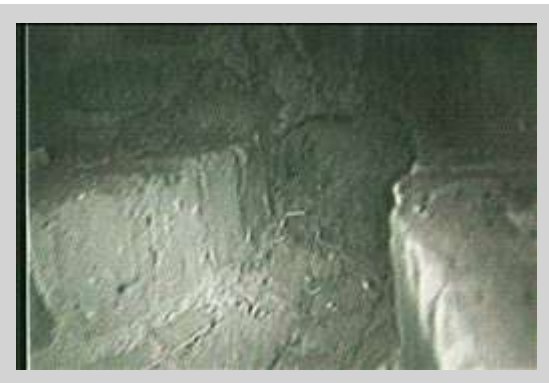
Pipe In @ 5 O'Clock

Connects To: **Stub connection / abandoned**

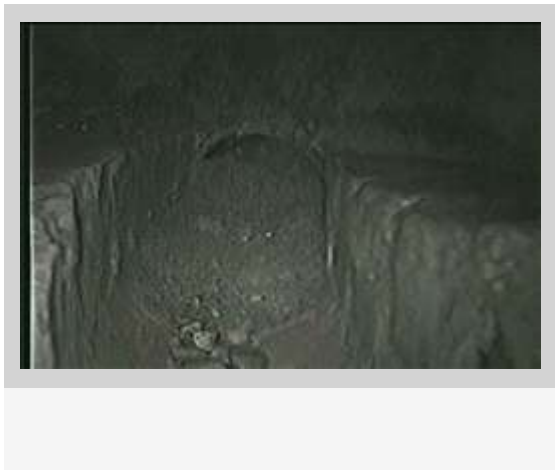
Pipe In @ 7 O'Clock

Connects To: **Stub connection / abandoned**
☐ Possible Illicit Connection
